COST-EFFECTIVENESS OF CRACK SEALING MATERIALS AND TECHNIQUES FOR ASPHALT PAVEMENTS

Final Report

STATE OF MONTANA
DEPARTMENT OF TRANSPORTATION
RESEARCH SECTION

April 2004

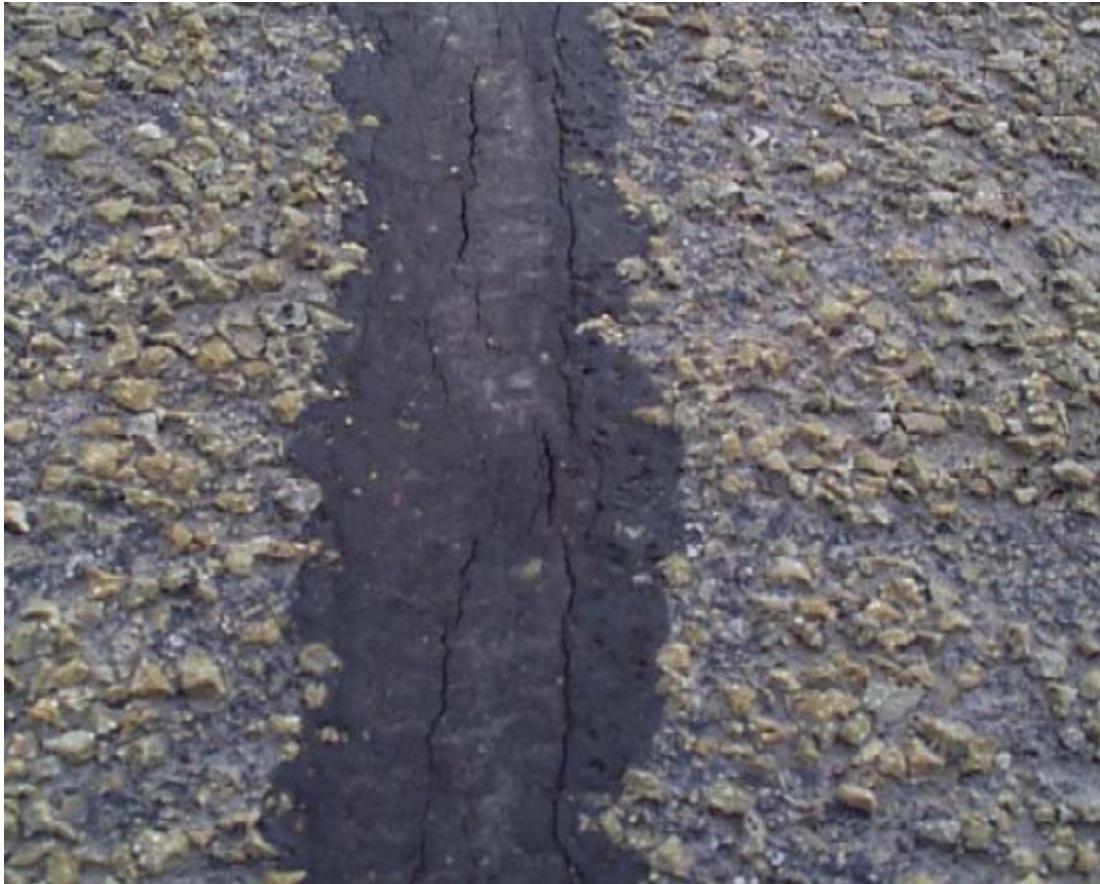
After approximately two years of service, adhesion failure was seen on both walls of a crack in a single reach (Figure 5) at the Helena site. In some cases, if more than half of the length of a crack was experiencing dual adhesion failure, the percent failure will be greater than 100. When calculating the total material failures the overlap will be accounted for, resulting in a value less than or equal to 100 percent. Dual adhesion failure of this type was seen in significant quantities in both of the Maxwell products as well as the Deery material. It is believed that failure of this type is likely to be the result of poor low-temperature resiliency. The combination of colder temperatures and pavement contraction causes internal stresses in the sealant to increase. If the sealant material does not have sufficient resiliency to resist these stresses, failure will ensue. In the past, stress relief had been provided through either cohesion or adhesions failures. Techniques that seem to be most prone to this behavior were the Square Reservoir and Flush, Square Reservoir and Band-Aid, and the Shallow Reservoir and Flush methods.

Figure 5: Example of Double Adhesion Failure Associated with the Shallow and Flush Technique
